Manhole Inspection Summary

Manhole # S13II_035MH

Insp Date: **3/4/09 1:19 PM**

Location Address: **1901 DUKELAND ST**

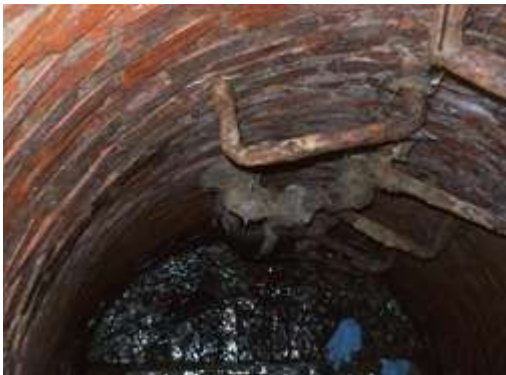
Defect 1

Surcharge ☒ **Evidence Of Surcharge** Depth: **8** (ft.) ☐ Active Surcharge Present

EVIDENCE OF SURCHARGE

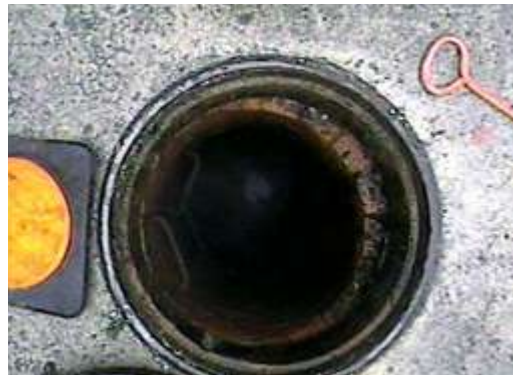
Defect 2

Frame Offset: **3** (in.) Condition: ☒ Sound ☐ Cracked ☐ Leaks

frame offset

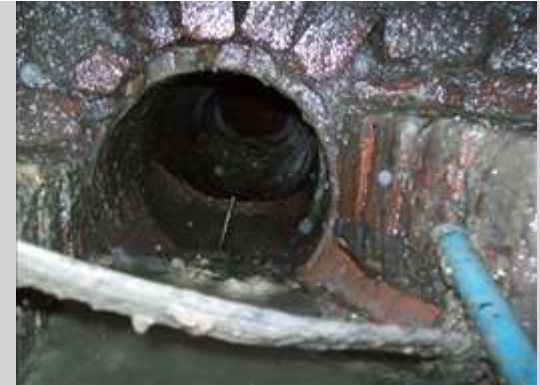
12 O'Clock Outflow

Pipe Height: (in.) Direct
Pipe Material: **Clay** ☐ Pipe Lined
Invert Depth: **18.06** (ft.) Flow Characteristics: **Fast**
Deposits: ☒ None ☐ Mud ☐ Sludge ☐ Debris ☐ Grease
Silt Depth: (in.) Deposits Extent:
Infiltration: **None** Pipe Seal Cond: **Sound**

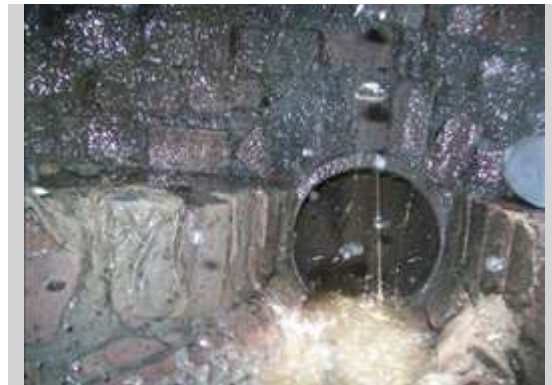
Drop In @ 3 O'Clock

frame offset

Drop: **Outside Direct**
Angled: Reading: (ft.)
Inv Depth: **17.96** (ft.)
Drop Condition: **Open**

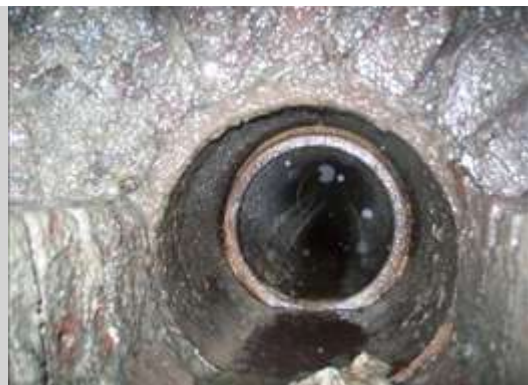
6 O'Clock Inflow

Invert Depth: **18.00** (ft.) Flow Characteristics: **Fast**

Deposits: ☒ None ☐ Mud ☐ Sludge ☐ Debris ☐ Grease

Infiltration: **None**

Pipe Seal Cond: **Sound**
